UNITED FIRST PARISH CHURCH (UNITARIAN)

HISTORIC STRUCTURE REPORT

Quincy, Massachusetts

April 1996

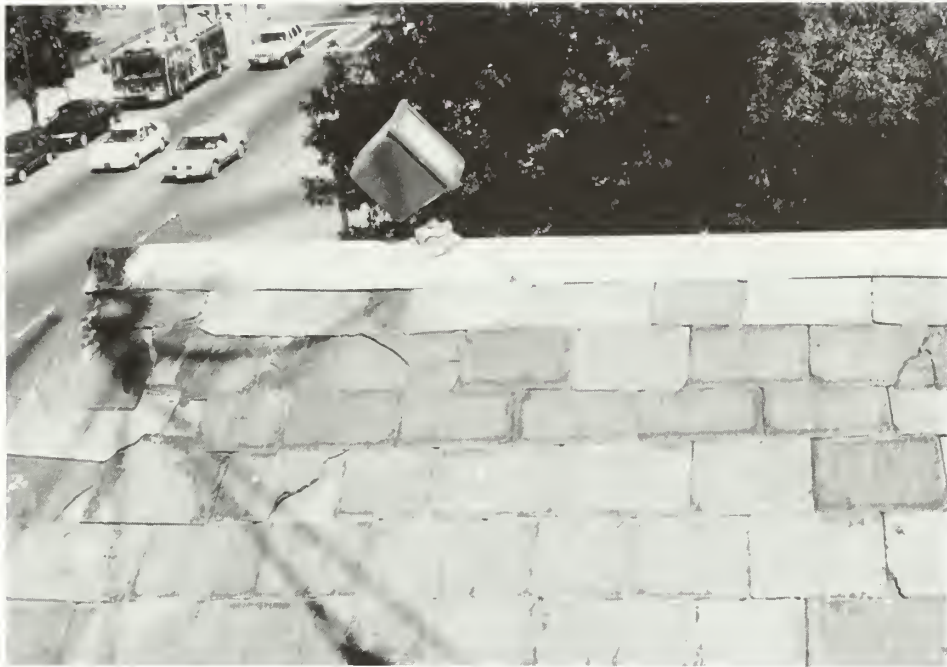
Figure 67. Tower exterior: west portico, slate roof with copper ridge cap. Note cracked and repaired slates, bituminous patches, loose copper flashing, and spotlight screwed to ridge cap.

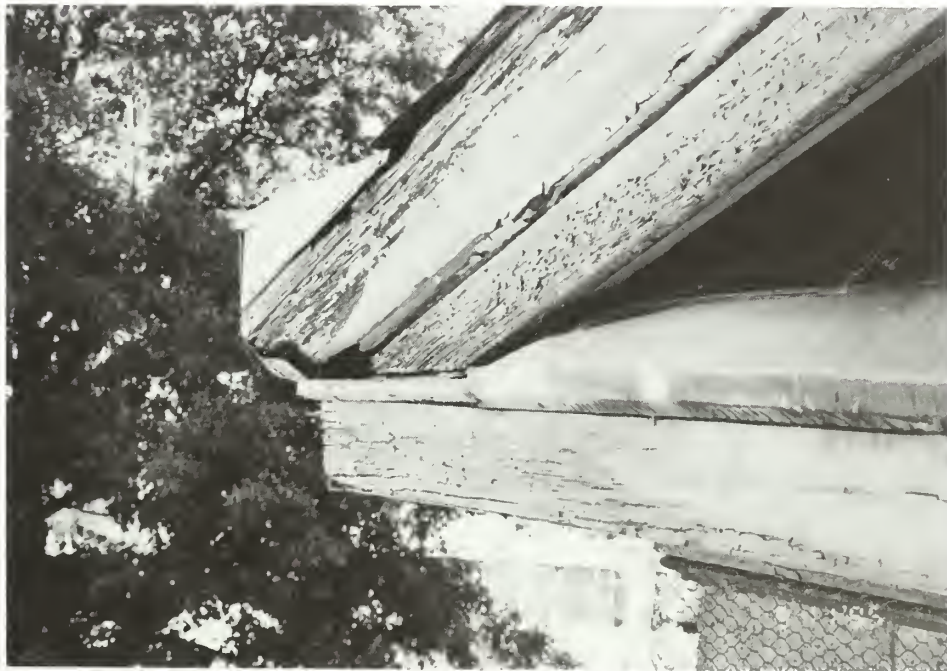
Figure 68. Tower exterior: west portico, north end of entablature. Note peeling paint, cracked moldings, open joints, and granite stains from rusting chicken wire.

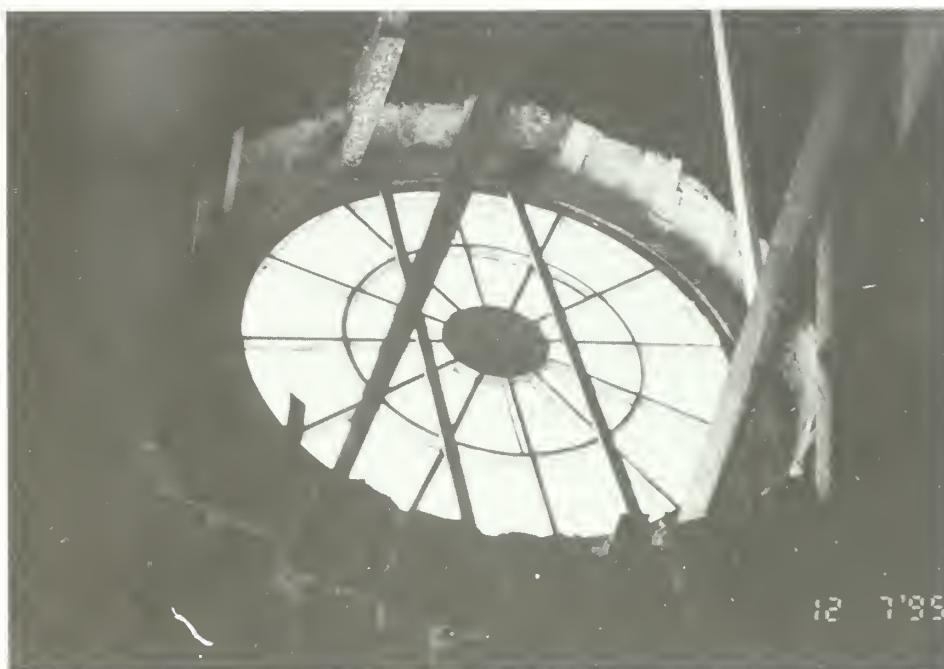
Figure 90. Church exterior: east wall, attic oculus (W302), with loose glazing, peeling paint, open joints; now covered with an exterior thermoplastic sheet.

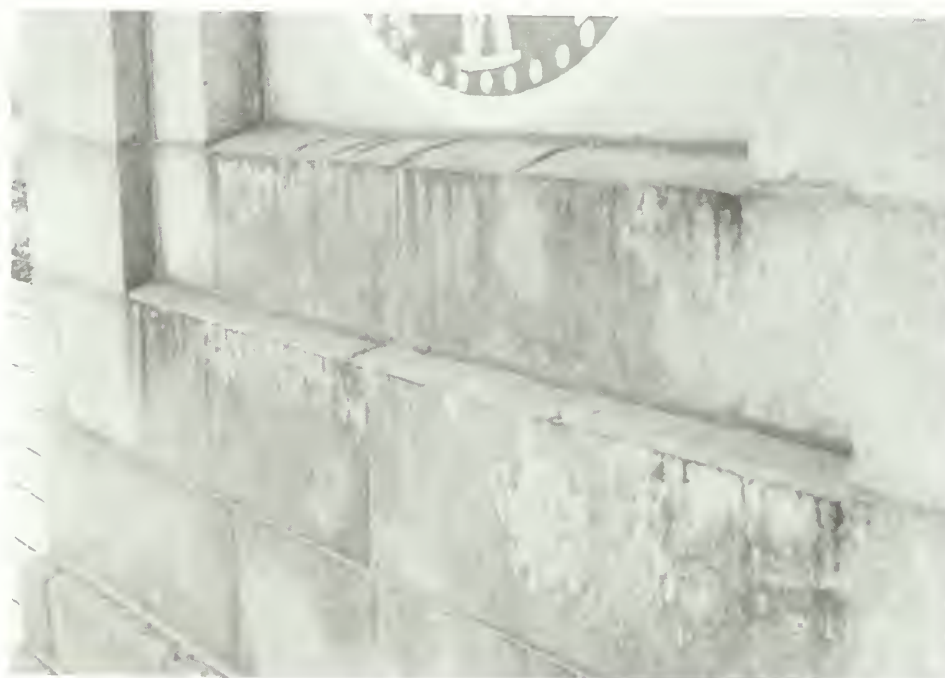
Figure 94. Tower exterior: shaft, north side below clock face. Note minor stains and discoloration and open joints of granite.

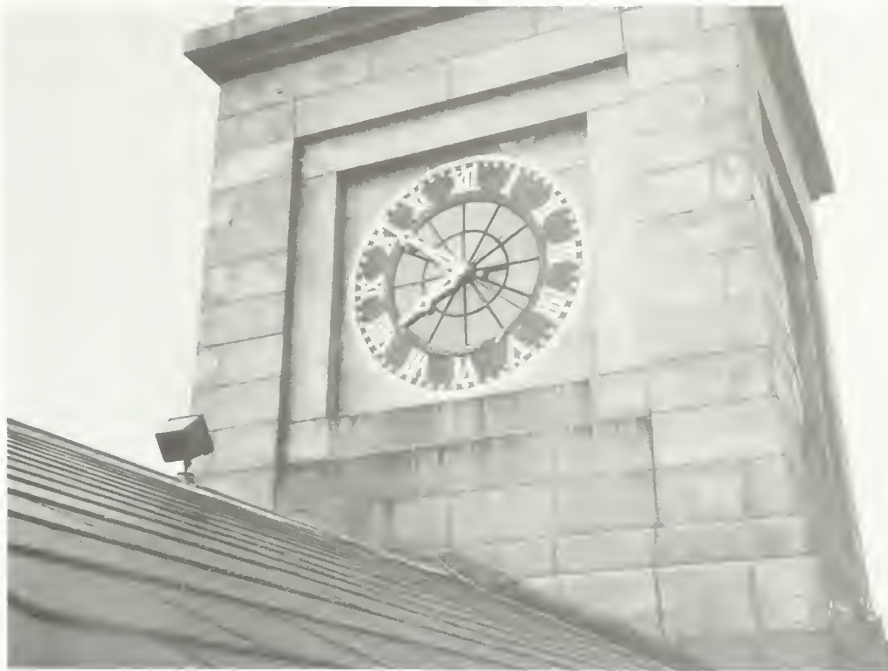
Figure 95. Tower exterior: shaft, east side with glazed clock face. Note open joints and stained granite, and spotlight attached to copper ridge cap.

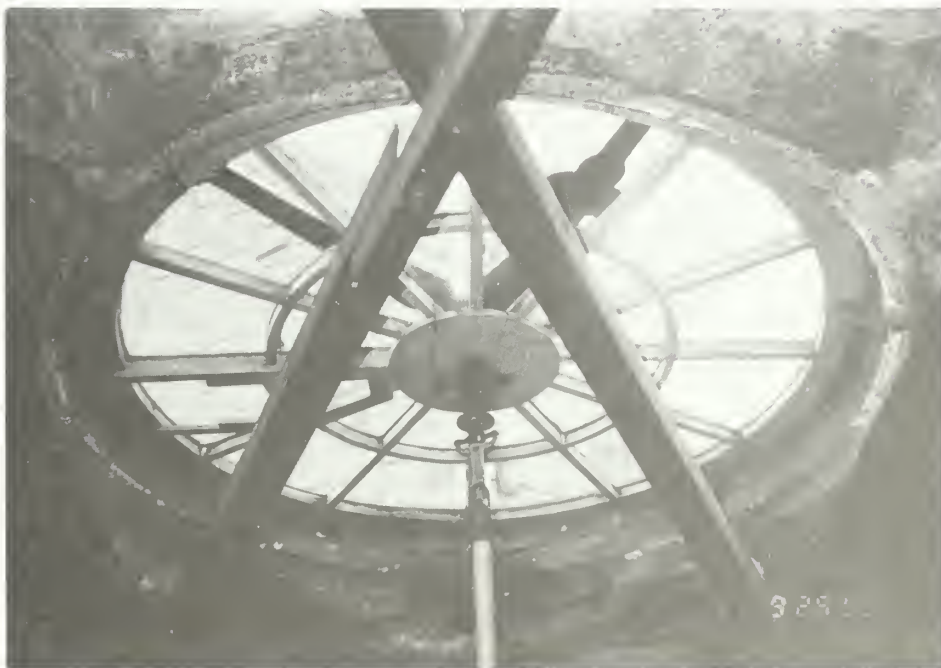
Figure 96. Tower interior: shaft, east clock face. Note lack of maintenance of wood elements, and modern interior tower support in foreground.

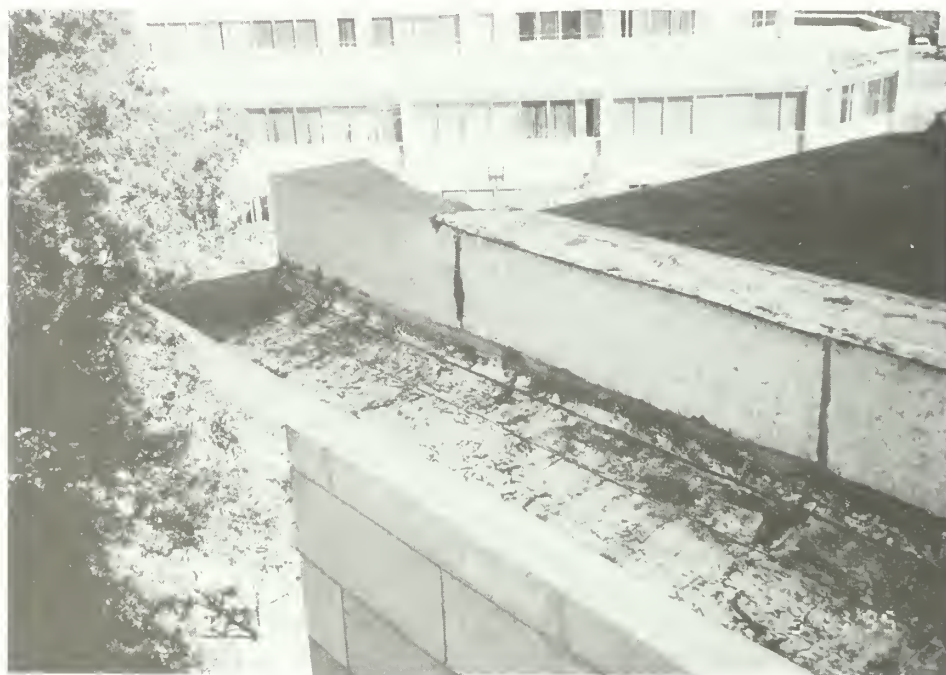
Figure 98. Tower exterior: base, north end of west parapet. Note inappropriate use of bituminous asphalt to seal masonry joints and to parch the copper flat-seam roof; flashing is missing from parapet wall.

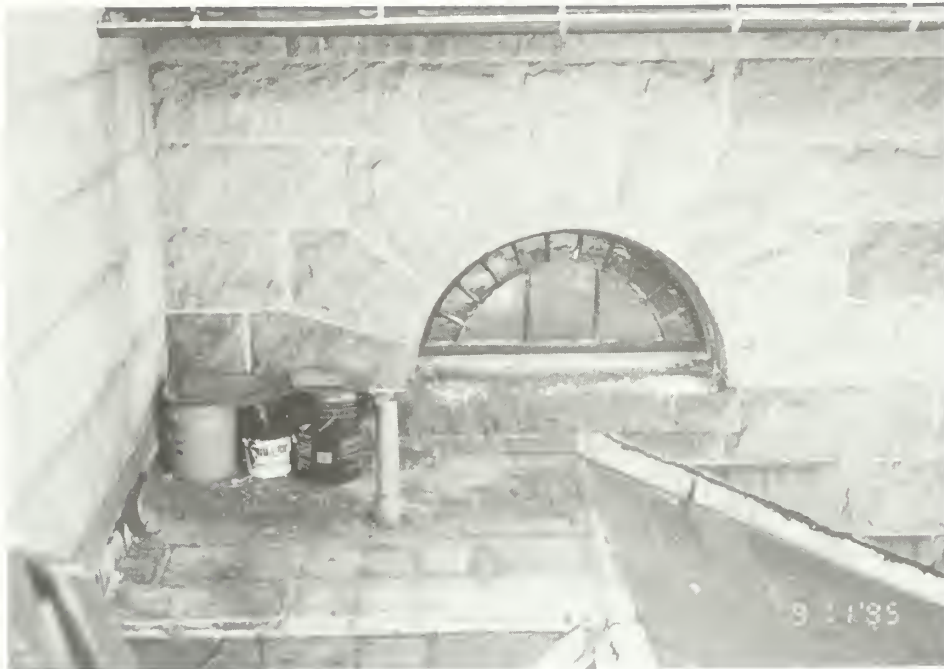
Figure 99. Addition exterior: intersection of south wall with church, showing roof of south wing and lunette window. Note surplus supplies left after last repair with bituminous asphalt; window has peeling paint and dry wooden components.

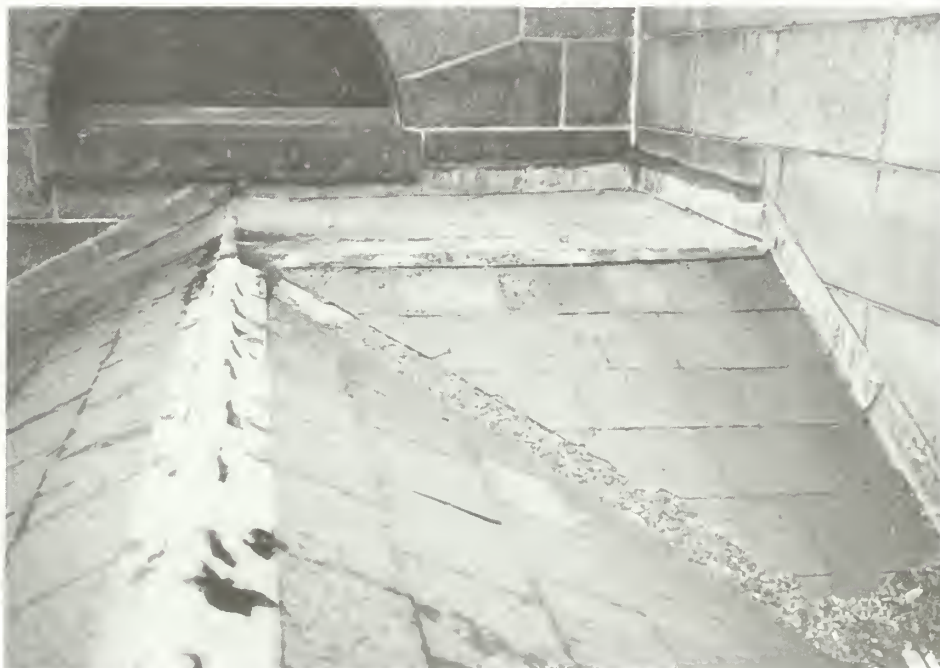
Figure 100. Addition exterior: intersection of north wall with church, showing roof of north porch and lunette window. Note bituminous patches on copper ridge cap and slate roof, clogged valleys, and peeling paint and open joints of window.

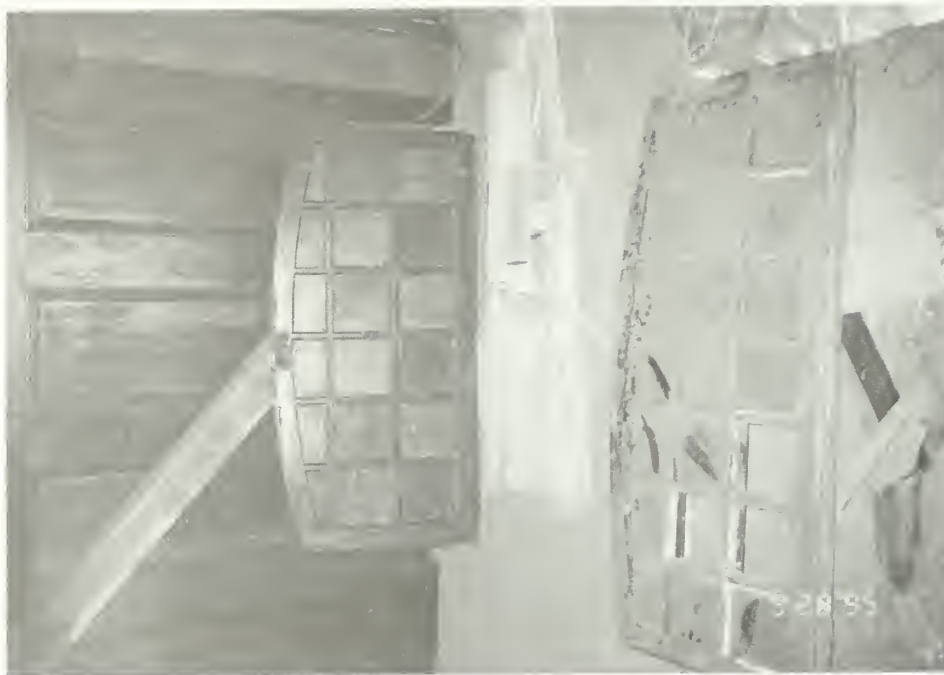
Figure 102. Sashes of south eyebrow window (W201) and north eyebrow window (W203), stored in attic. Note peeling paint and missing ribbed, colored glass.

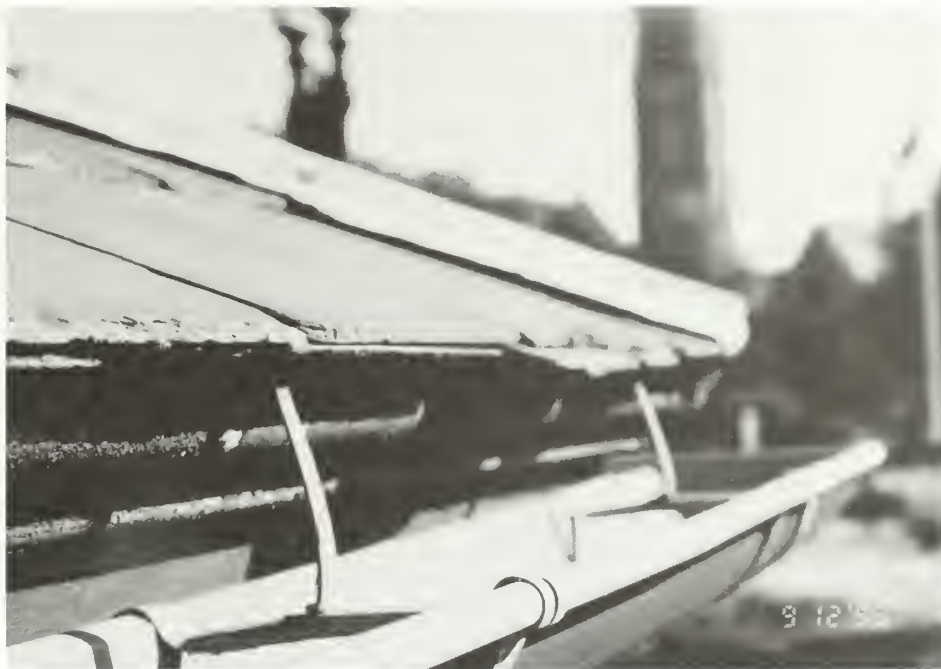
Figure 103. Addition exterior: east end of south half-round copper gutter and cornice. Note lifting slates and hip ridge cap, and peeling paint, dry wood, and open joints of cornice.

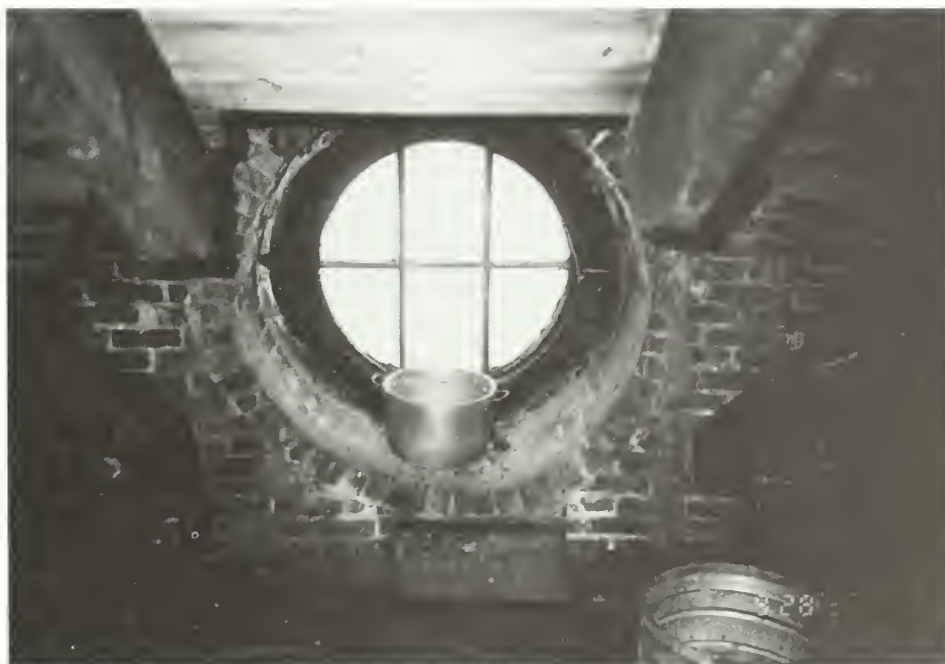
Figure 104. Addition interior: east wall, attic oculus (W202). Note effects of leaks through the flashing and/or the open joints of the sash and surround, and repointing of brickwork.

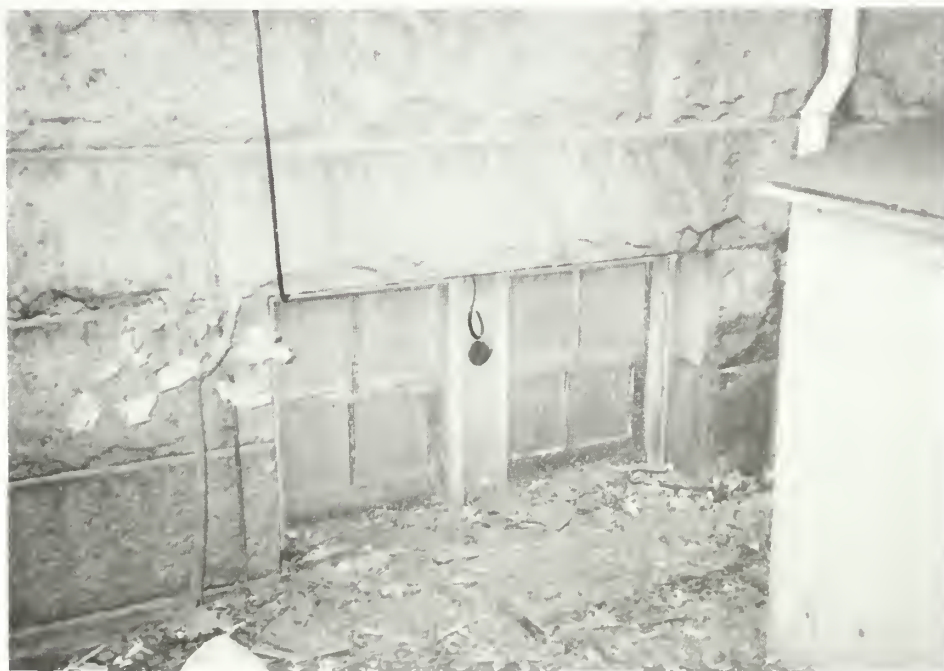
Figure 108. Addition exterior: north wall, basement window (W015). Note wire security mesh, soil above sill level, peeling paint, and biological growth, which affect both windows and the granite foundation.

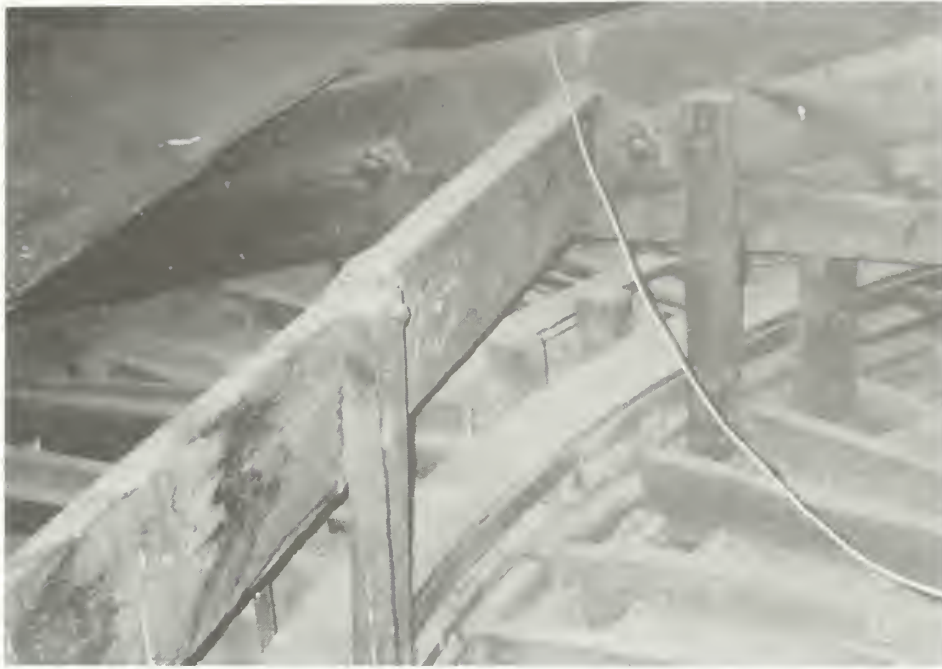
Figure 109. Church interior: attic, view of framing of sanctuary's coffered ceiling dome. Note scissors truss and water stains from roof leaks on many of the wooden elements.

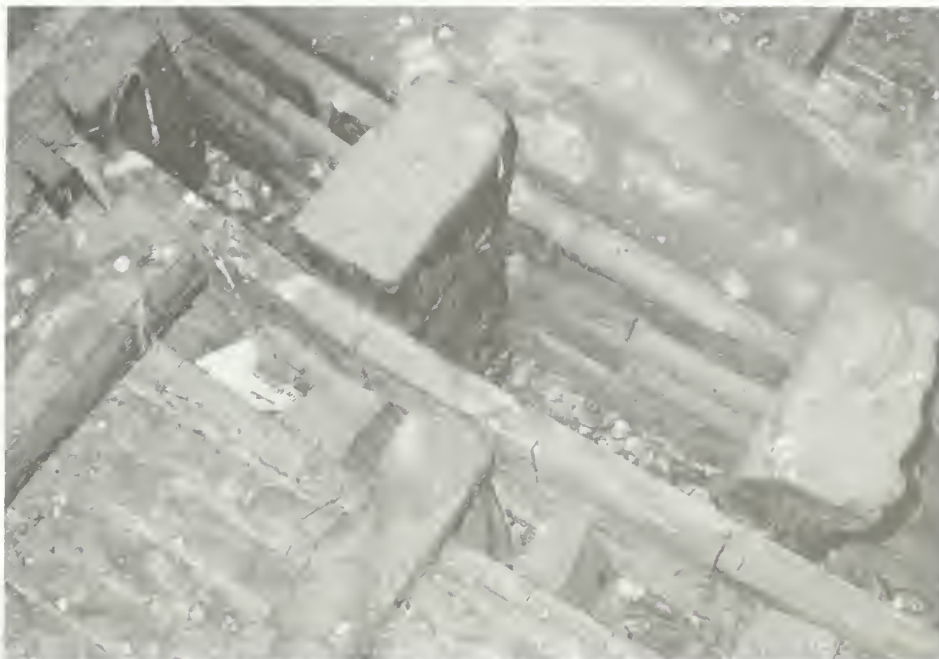
Figure 110. Church interior: attic, view of plaster keys of sanctuary's coffered ceiling dome. Note accumulation of debris and pigeon droppings, although bird access now seems blocked.

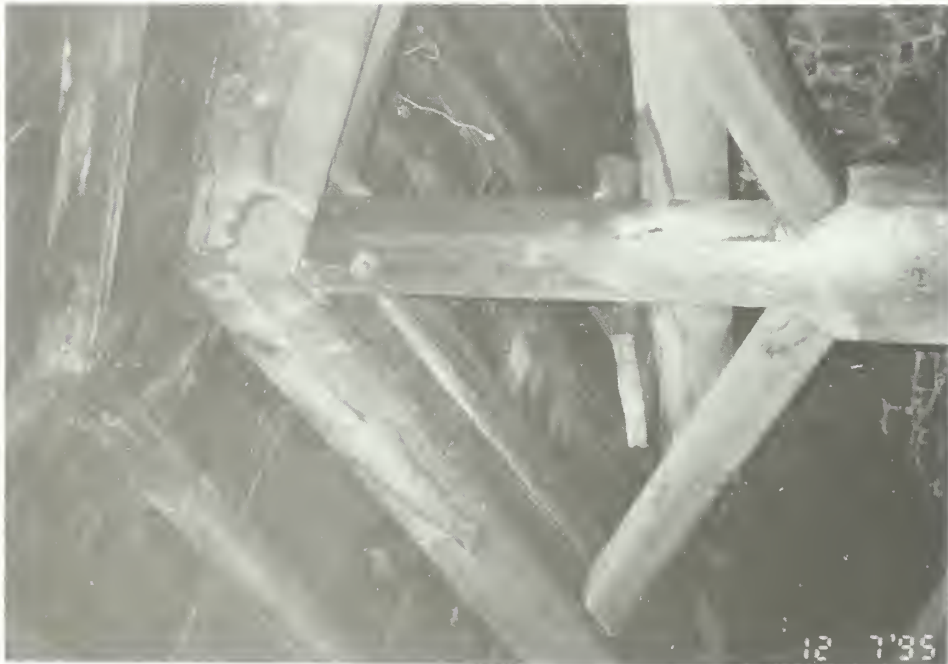
Figure 111. Church interior: attic, westward view of king post, rafter, and sheathing. Note water damage from leaks, mold growth, and rusting chicken wire.

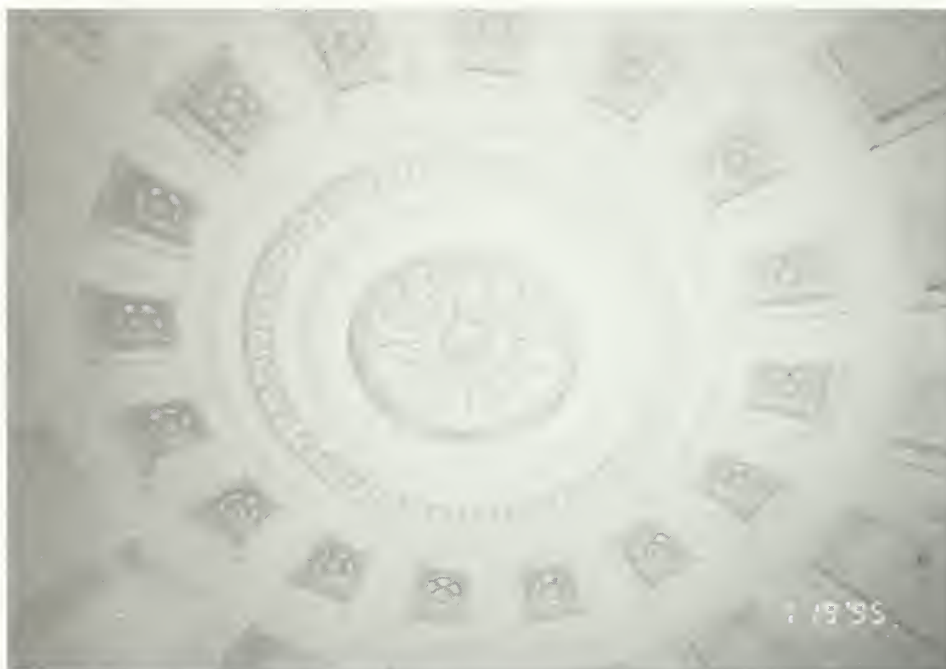
Figure 115. Church interior: sanctuary (Room 103), coffered dome ceiling.
Note minor areas of diagonal cracks and water stains from roof leaks.

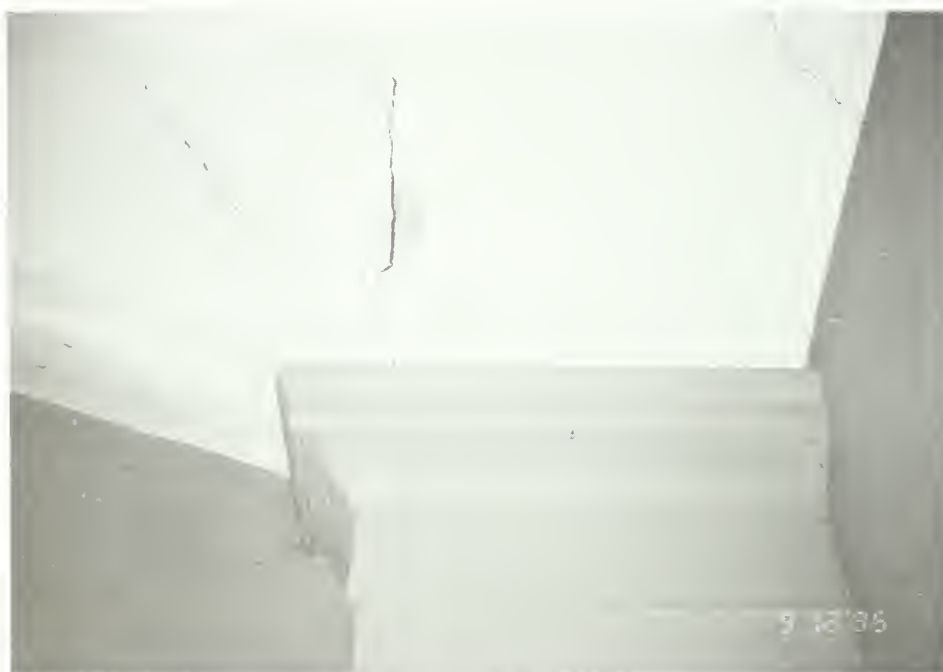
Figure 116. Church interior: sanctuary (Room 103), southwest corner at
intersection of ceiling and wall pilaster. Note largest plaster-wall
crack and water stains from leaks.

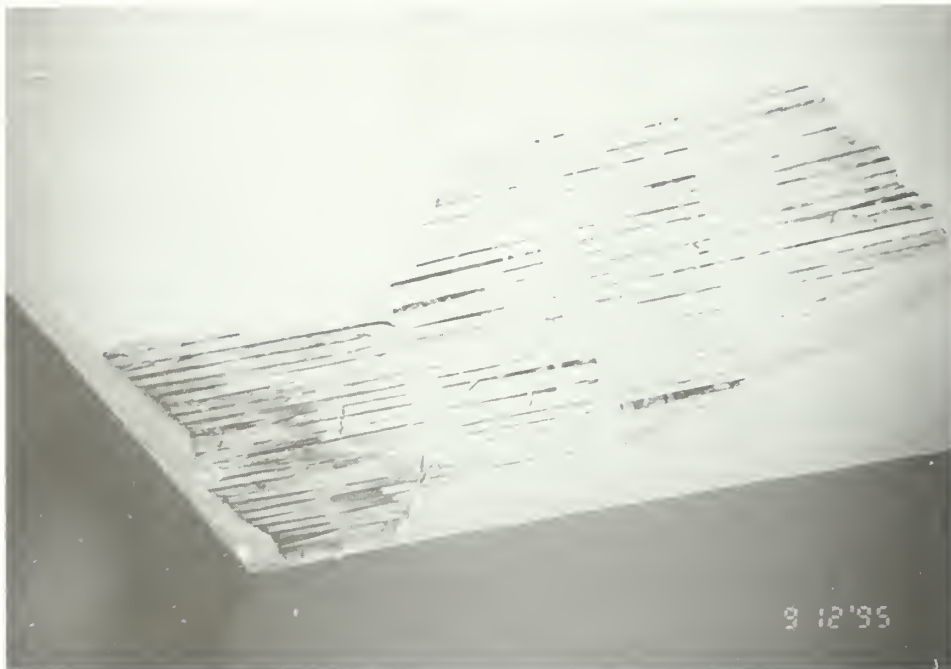
Figure 119. Tower interior: second-story vestibule south room (Room 202), southeast corner of ceiling where plaster has fallen due to failed plaster keys due to roof leaks.

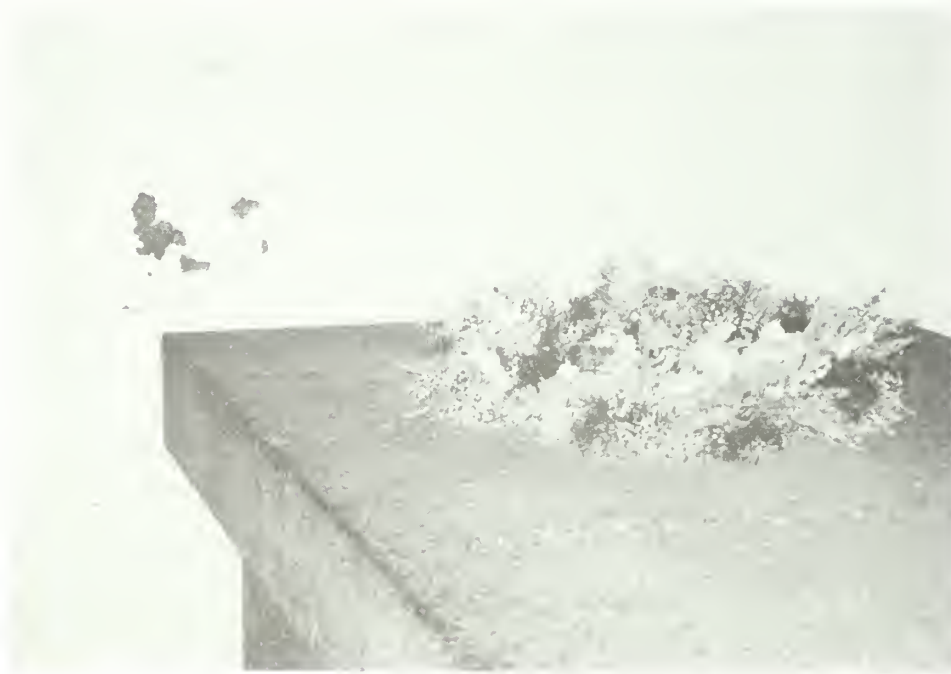
Figure 120. Tower interior: basement crypt south room (Room 003), west wall. Note whitewash peeling from granite wall due to moisture penetration of wall.
